DON'T LOSE YOUR INHIBITIONS

Since I bought my MGB three years ago the overdrive has only worked in 4th gear (it should work in 3rd and 4th gears).

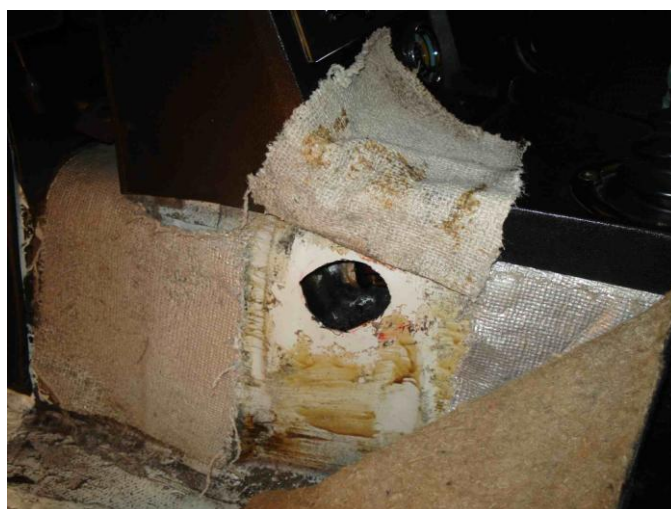
allow me to shine a torch into the tunnel to check the final position of the access hole and adjust it if necessary. Then I used the Dremel to cut out the final oval access hole about 65mm x 55mm (Figs 2, 3 – note to self, hole could be a bit neater!).

Fig 2. Access hole in transmission tunnel.

Fortunately, the hole I cut was in the correct position. If anybody is contemplating doing this in future the centre of the hole needs to be on the passenger side of the transmission tunnel as high up as possible, and about 165mm forward of the gear lever.

Having first pushed the passenger seat as far back as possible I peeled back the carpet and the heat and sound insulation from the transmission tunnel. I measured, and re-measured, to decide the location of the access hole and drilled a 3mm hole in the centre of where I thought the switch location was. I put a bit of flex through the hole to dangle down inside the tunnel. From underneath the car I could see the flex was in roughly the right position next to the switch. I then cut out a 20mm square in the tunnel at this position with a cutting disc in a Dremel (a saw blade would be too long and could damage the switch). This was to

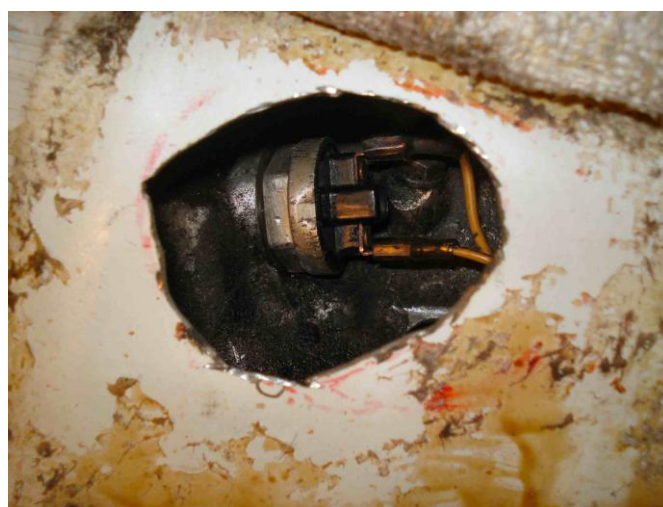
Fig 3. Close up of access hole showing inhibitor switch.

I removed the two wires from the spade terminals on the switch with needle nose pliers. The next problem was finding a spanner to remove the switch itself. The switch has a hexagon nut that is about 30mm across the flats. This nut is sandwiched between the gearbox casing and a larger diameter part of the switch (see Fig 3), so it requires a big spanner with thin jaws, which is not a combination I had! Fortunately, I found I could grip the switch with a pair of plumbers' adjustable water pump pliers, the angled head on the pliers being also useful for access. Being careful not to damage the switch, I found I could move it a little at a time before the pliers fouled on the edge of the access hole and they had to be re-positioned. It was slow work but eventually I was able to remove the switch.

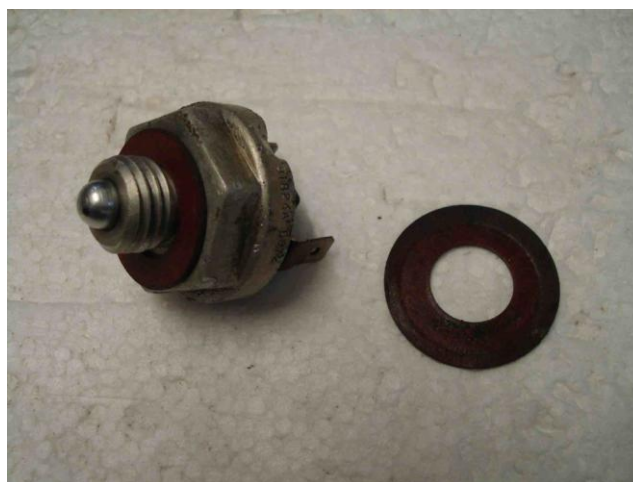
Fig 4. Overdrive inhibitor switch showing one fibre washer removed.

My switch had two fibre washers fitted, one of which I now removed (see Fig 4). I then cleaned up the switch and the contacts, checked it was working, and re-installed it. Before attaching a cover over the access hole, I checked the inhibitor switch was now doing its job by attaching a 12v bulb into the electrical circuit of the overdrive wiring. I then switched on the ignition and the dashboard overdrive

switch and put the gearbox into 3rd then 4th gear. Success, the bulb lit up both times! I then checked 1st, 2nd and reverse and, as expected, the bulb didn't light, showing that the switch was 'inhibiting' the overdrive in these gears.

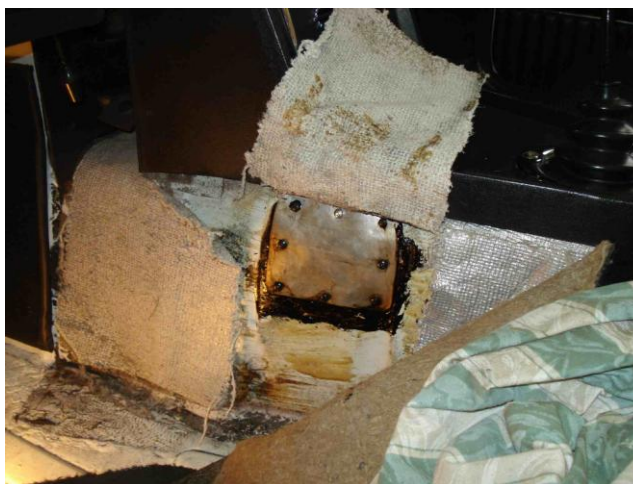
Fig 5. Cover plate fitted.

I then fixed a cover plate over the access hole, sealing it with underseal, and attaching it with self-tapping screws, Fig 5. If I need to access the switch in the future it should only take about half an hour to remove it.
