## RETURN TO SENDER

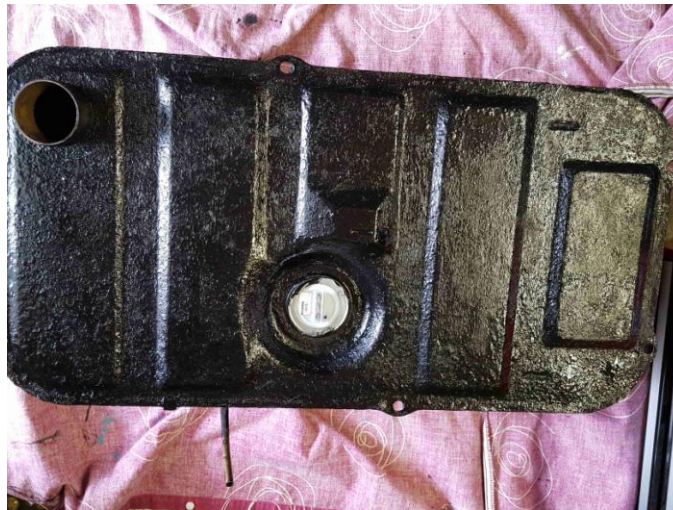
Once we had power as far as the gauge, we then turned our attention to the sender unit in the tank. Unlike the MGB, where the sender unit is on the side of the tank, in the case of the Midget the sender unit is on the top of the tank, and the tank has to be emptied and removed before the unit can be accessed (Fig 1).

Fig 1. Top of petrol tank showing sender unit (white).

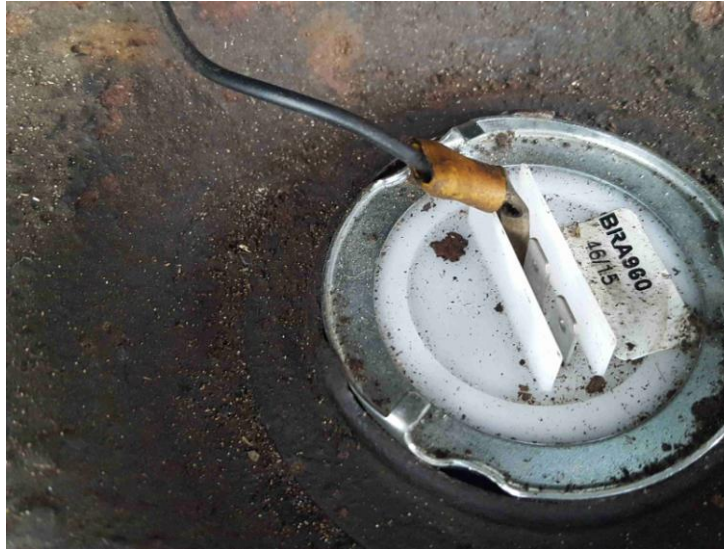
Dave had removed the tank and found that the sender unit looked very new, and also there was only one connection onto the sender unit, although there were three spade terminals available (Fig 2).

Dave's sender unit appeared to be a fairly new aftermarket item which was made largely of nylon, so that it would not earth to the petrol tank like the original design would, and it would need a separate earth. Therefore the way this 'new' sender unit was installed it would never have worked. We assume the previous owner had not realised the need for a separate earth and had just given up after replacing the sender unit, re-installing the tank, and finding his gauge still did not work!

Fig 2. Top of sender unit showing original single connection wire.

We are not sure why there are three spade terminals on the 'new' sender unit while just two (live and earth) are needed. The third connection may be for a low fuel level warning light, not normally fitted to the Midgets, and therefore in this case redundant.

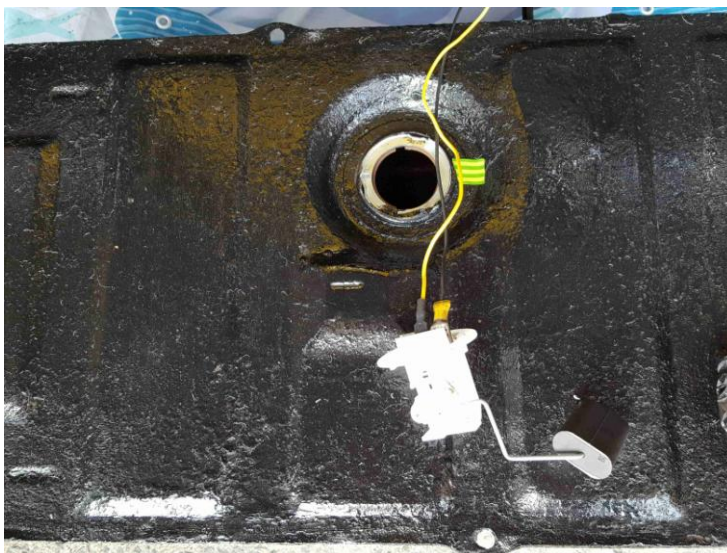
We removed the sender unit from the tank and put an AVO meter across two of the terminals. By moving the float from the down (tank empty) position to the up (tank full) position we got resistances of 210 ohms and 19 ohms respectively. These values agreed well with published figures, so we were confident that the sender unit was working properly and the main problem was the lack of an earth lead on the unit.

Fig 3. Sender unit outside tank showing float arm and two connections to the unit (one live, one earth).

We then connected an earth lead to one of the terminals on the sender unit and fixed it to a suitable earth point inside the boot.

Before putting the unit back in the tank, and bolting the tank back underneath the car, we tested everything by moving the float arm up and down manually and checking that the gauge was responding as it should. Problem solved for the cost of a metre of wire!
