SMOKE GETS IN YOUR EYES

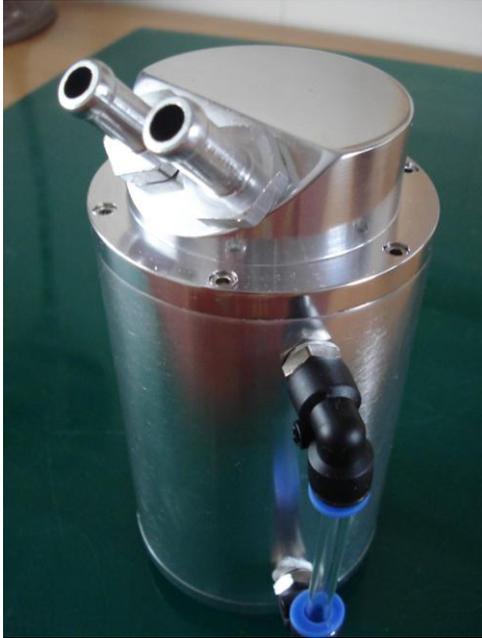
We were able to find an oil catch tank on e bay for £19 including fittings, so thought it was worth giving one a try. The tank has an inlet and outlet pipe, an oil level sight tube on the side, and a drain plug on the bottom of the tank.

Catch Tank before installation

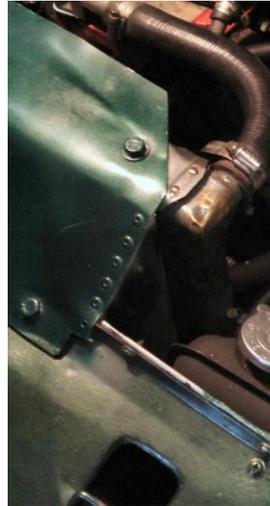
Catch Tank installed into engine breather

The tank was plumbed into the breather pipe system, between the canister on the engine and the Y piece to the carburettors. Having installed the catch tank we went for a test drive and there was no evidence of any smoke, so hopefully this has cured the problem – time will tell!
